RE: **Phase I Environmental Site Assessment**
Proposed Sandhill Crane Apartments
3099, 3101, 3113 & 3119 W. Moore Street
Boise, Idaho

Phase I Environmental Site Assessment
Proposed Sandhill Crane Apartments
3099, 3101, 3113, and 3119 W. Moore Street
Boise, Idaho

**Phase I Environmental Site Assessment
Proposed Sandhill Crane Apartments
3099, 3101, 3113, & 3119 W. Moore Street
Boise, Idaho**

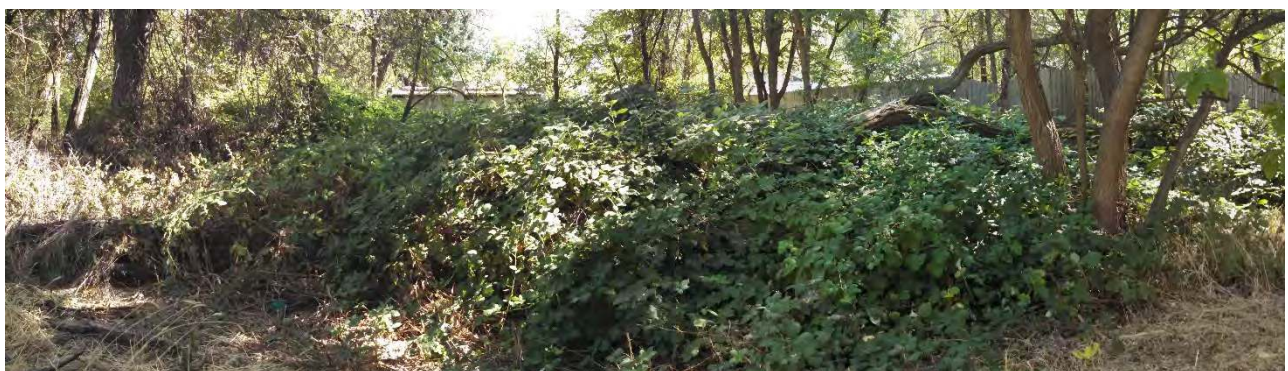
Photograph 6: Blackberry thicket observed along east-central boundary. View looking to the northeast.

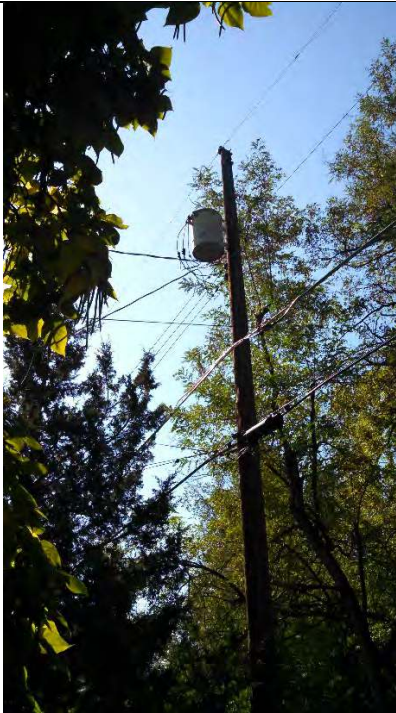
Photograph 19: Non-PCB labeled electrical transformer observed along the southeastern site boundary. View looking to the southeast. Staining was not observed on the transformer casing or on the ground beneath the transformer.

Two pole-mounted transformers were observed on separate power line poles in the northern site area. A blue “non-PCB” label was affixed to one transformer casing, while the second transformer was not labeled (Appendix D, Photographs 19 and 20). Evidence of transformer oil staining or leakage was not observed on either transformer casing or on the ground beneath each transformer. The transformers do not represent a REC at the site.

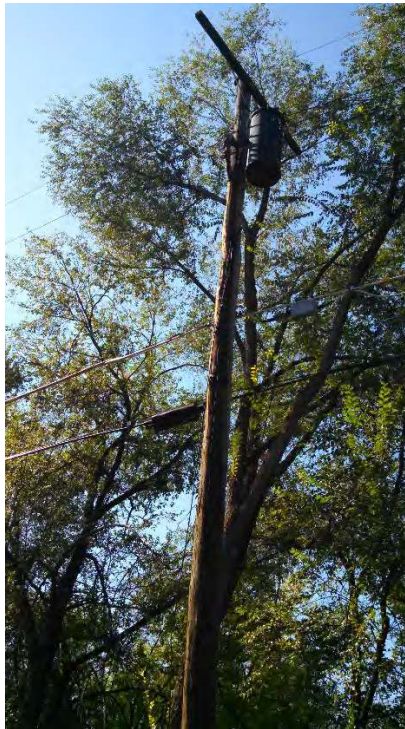
Photograph 20: Unlabeled electrical transformer observed near the north-center site area. View looking to the south. Staining was not observed on the transformer casing or on the ground beneath the transformer.

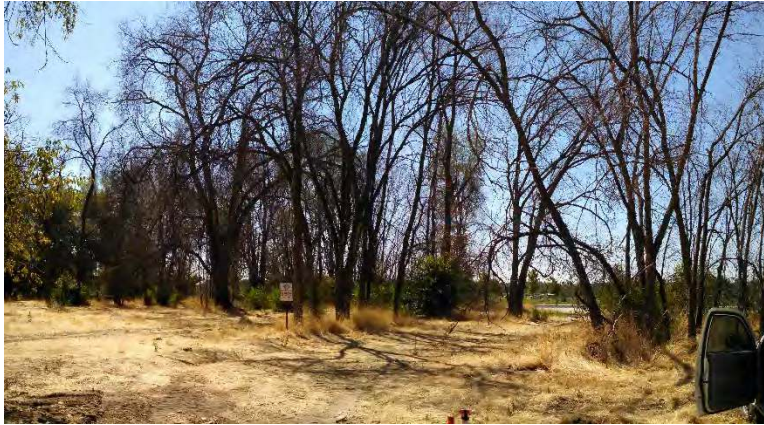
Photograph 21: Dead trees observed in the southwestern site area. Saplings and volunteer growth was observed at the base of the dead trees and in opens space around the trees.

Dead mature trees were observed in the southwestern site area (Appendix D, Photograph 21). However, new saplings and volunteer growth was observed at the base of the trees and in open space around the trees. The dead trees are not considered a REC with respect to the site at this time.

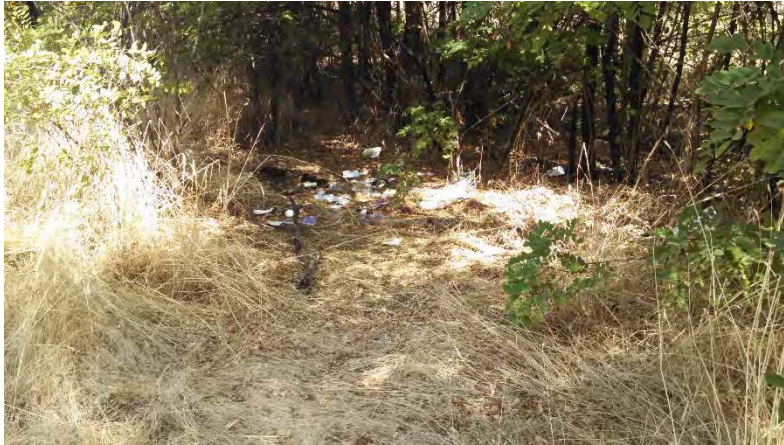
Photograph 22: Household trash observed near the site center. View looking to the north.

Wind-blown and household trash was observed during the site reconnaissance (Appendix D, Photograph 22). The trash was not hazardous in nature and does not represent a REC at the

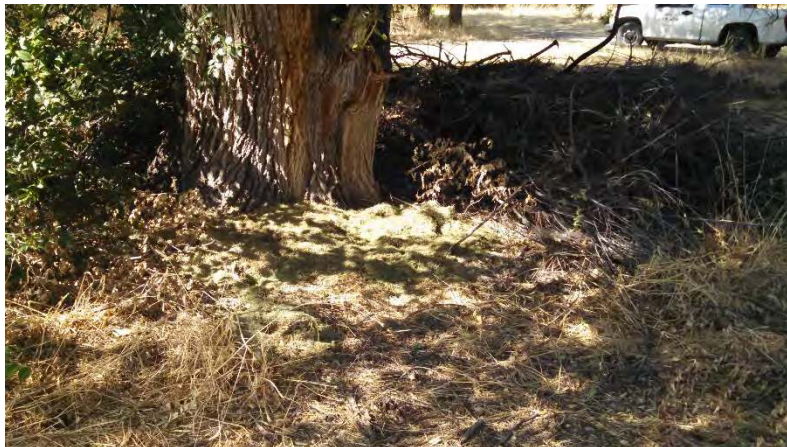
Photograph 23: Dumped grass clippings observed along the northeastern site boundary. View looking to the southwest.

Yard waste including lawn clippings and tree branches were observed on the northeastern site portion (Appendix D, Photographs 23 and 24). Small chunks of asphalt were also noted (Appendix D, Photograph 25). The dumped yard waste and asphalt are not considered RECs to the site at this time.

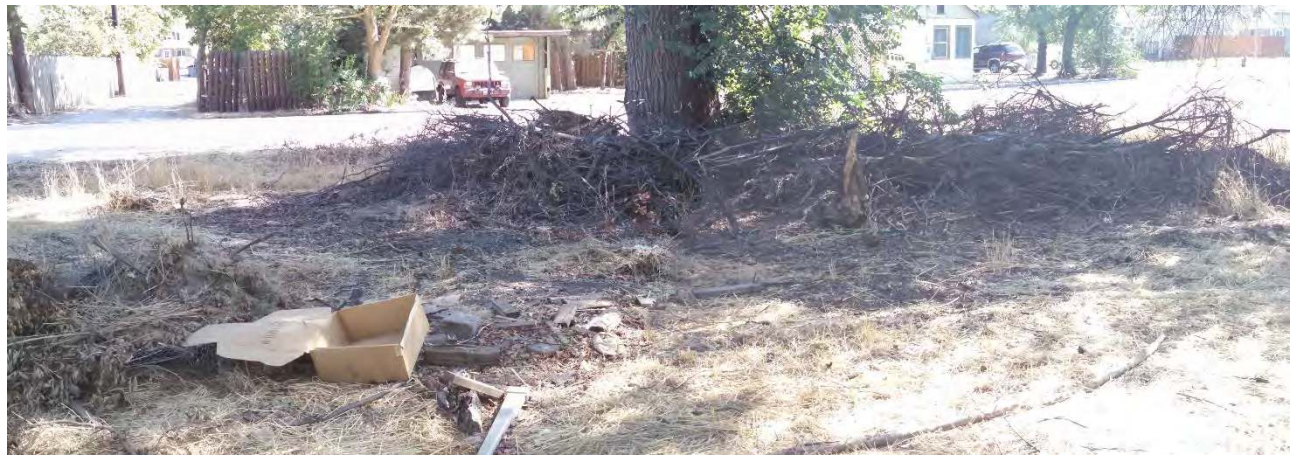
Photograph 24: Lawn debris (branches) and trash observed near the eastern site corner. Residences along W. Moore Street are in background. View looking to the east.

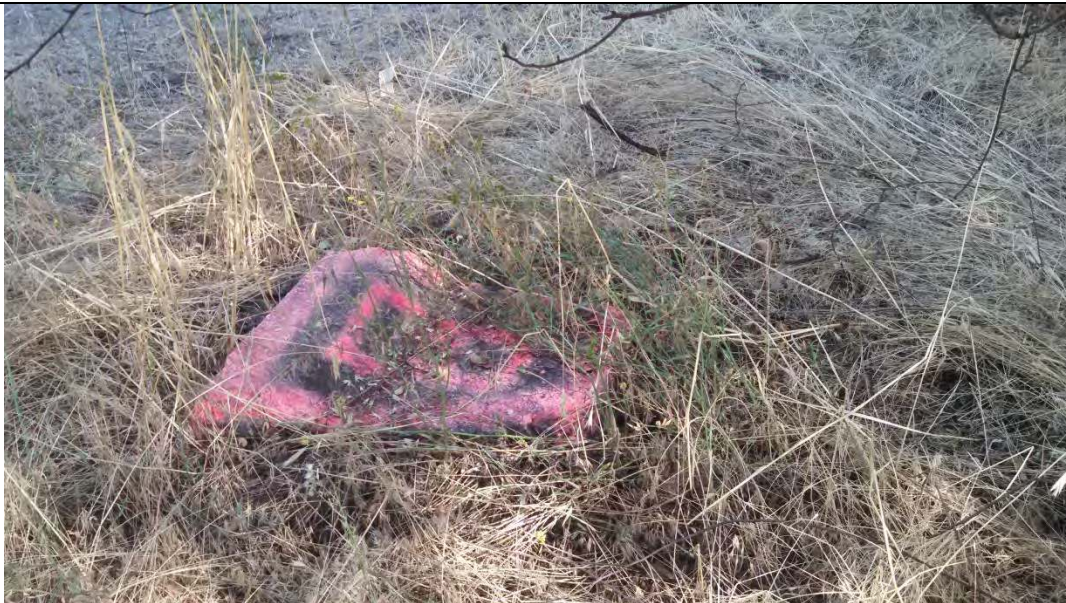
Photograph 25: Asphalt chunk observed in northeast portion of site.

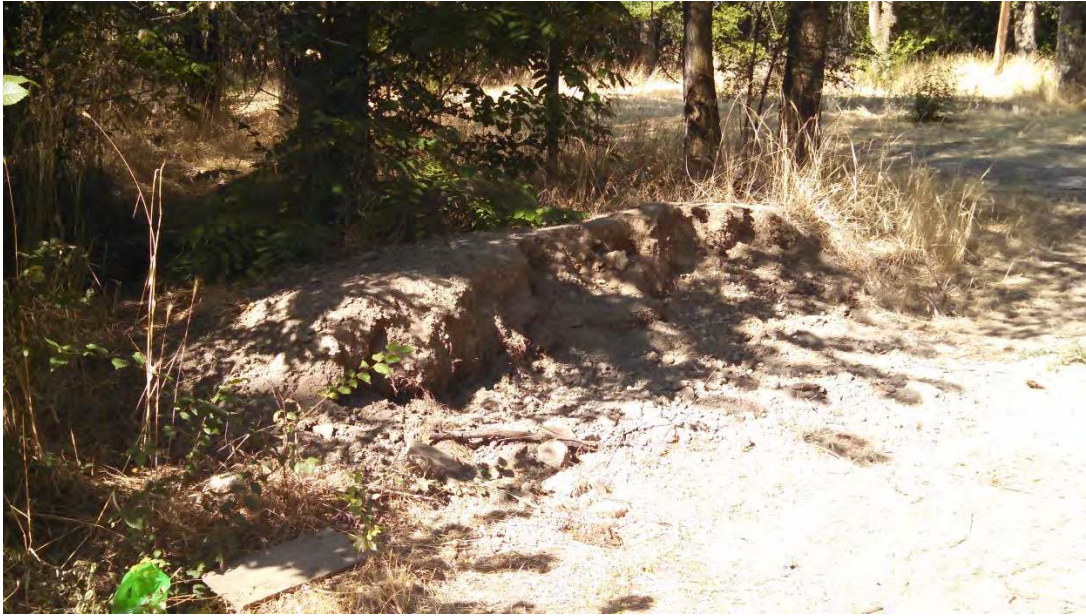
Photograph 26: Fill dirt pile observed near eastern site corner. Pile was comprised of silty sand. Staining was not observed and odors were not noted in the soil pile. View looking to the south.

A small fill dirt pile was observed on the northeastern site portion (Appendix D, Photograph 26). The fill pile was comprised of silty sand, and may have originated as dredge material from the adjacent irrigation ditch. Staining was not observed and odors were not noted in the fill pile. The fill pile is not considered a REC to the site at this time.

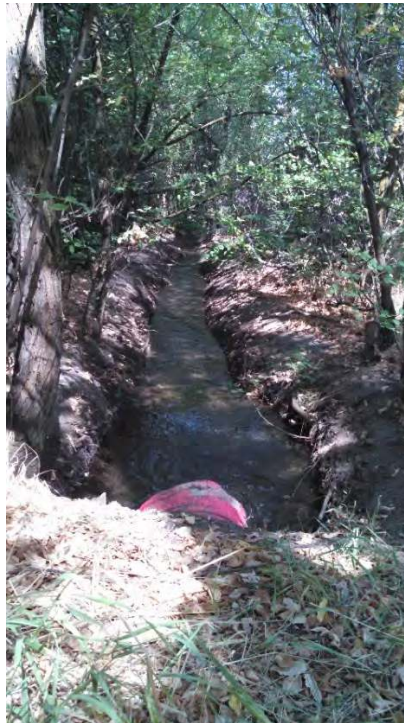
Photograph 27: Irrigation ditch which traverses the northern site portion. View looking to the northwest.

An irrigation ditch traverses the northern site portion (Appendix D, Photographs 27 and 28). Water was flowing in the ditch at the time of the site reconnaissance. Evidence of sheens or odors was not noted in the ditch water. The irrigation water is not considered a REC to the site at this time.

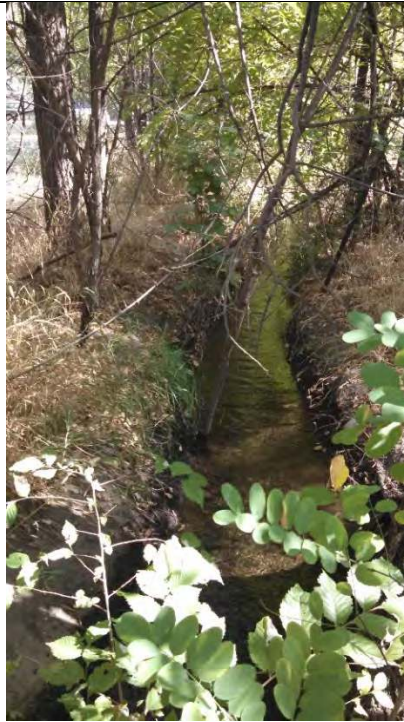
Photograph 28: Irrigation ditch which traverses northern site portion. View looking to the northeast.

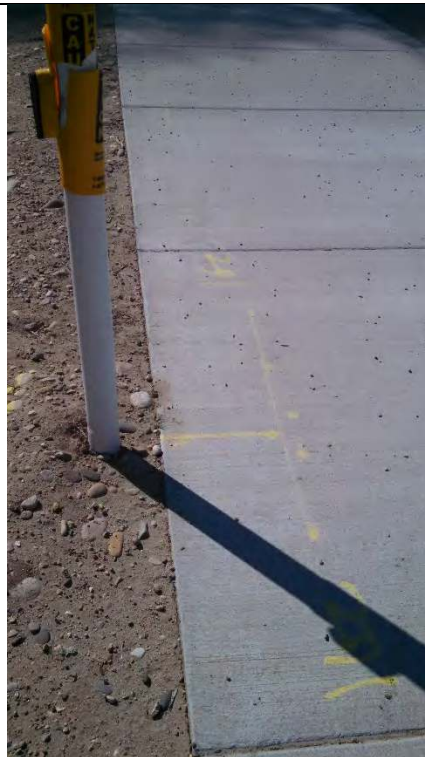
Photograph 29: Natural gas pipeline marker observed along N. Whitewater Park Blvd. Markings indicate the pipeline runs parallel to N. Whitewater Park Blvd. and does not traverse the site.

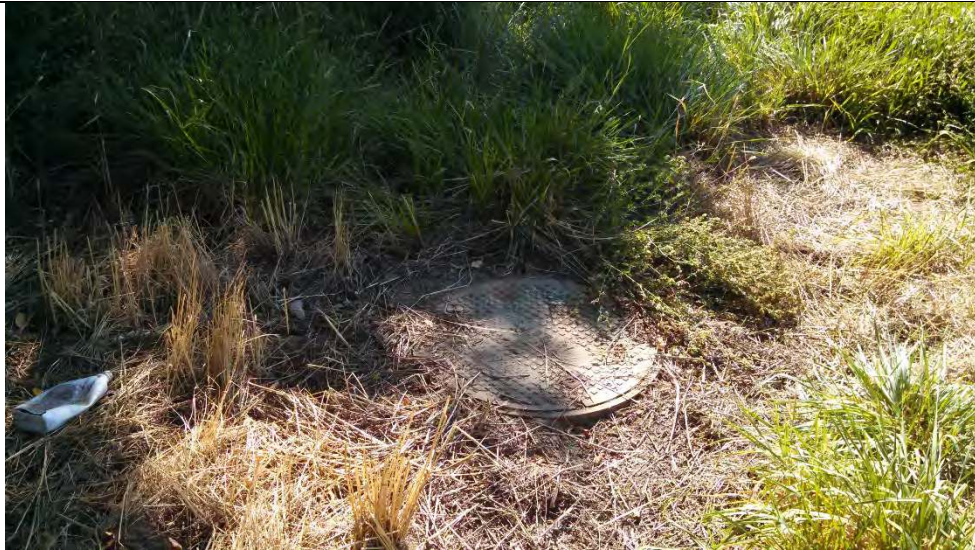
Photograph 30: Sanitary sewer manhole cover observed in the northwestern site area. City of Boise sewer line traverses the site from W. Moore Street southwest to N. Whitewater Park Blvd.
